New Fire Doors Inspection Report		Project: WO-LT0082AMD2 Sardar Kabuli Girls' High School Fire Door Replacement QA Services
Location:		Contract Number:
Dar-ul-aman Road, Qala-e-Raees, Kabul, Afghanistan		AID-306-TO-15-00014
Inspection Date:		Coordinates:
May 23, 2016		Latitude: 34.484997 N° Longitude: 69.137351 E°
Inspectors:	Status: N/A	Weather: Sunny (20 °C)

EXECUTIVE SUMMARY

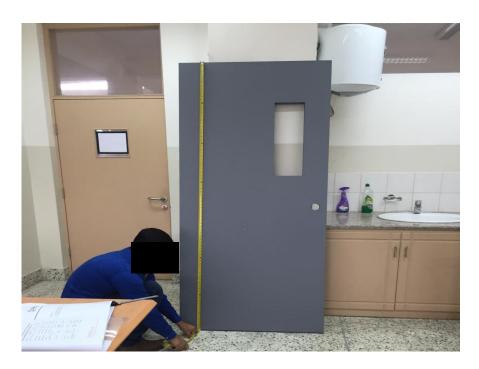
- The new doors, as well as the frame height, width and thickness, vision lite and its frame size were measured for conformance to the preapproved drawing specification submitted to Tetra Tech. All checked components met the requirements.

Photograph-1: Hollow metal door height measurement by Tt QA Engineer.

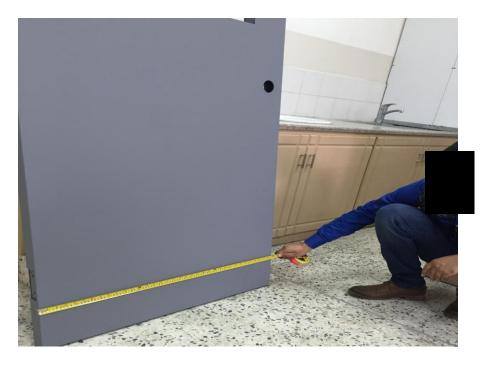
Photograph-1: Hollow metal door width measurement by Tt QA Engineer.

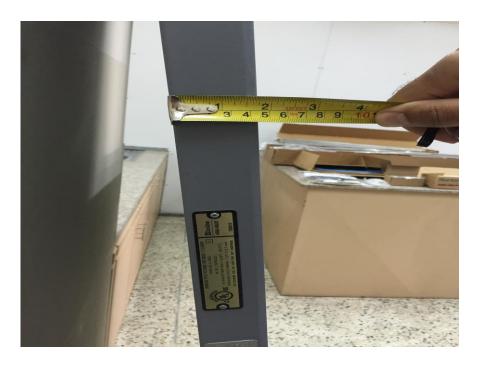
Photograph-3: Hollow metal door thickness measurement by Tt QA Engineer.

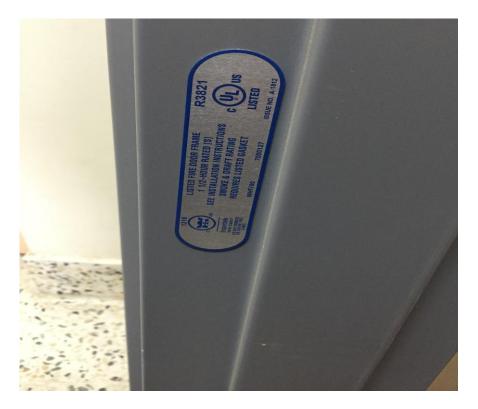
- 4. All of the checked components of door (door panels, door frame, door closures, handle sets, panic hardware, heavy weight hinges, and vision light frame...etc.) were tested and approved by a UL Standard Certification Company as the components were labelled with a UL mark.

Photograph-4: Fire Door frame labelled with UL Standard stamp.

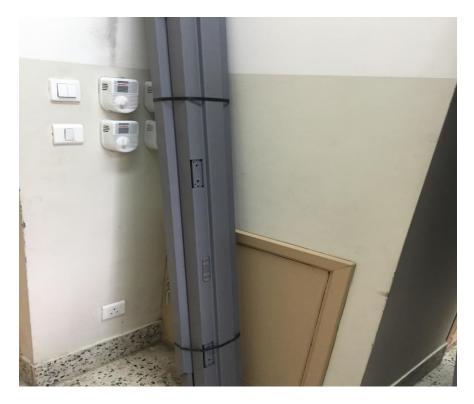
Photograph-5: Fire door frame marked with UL Label.

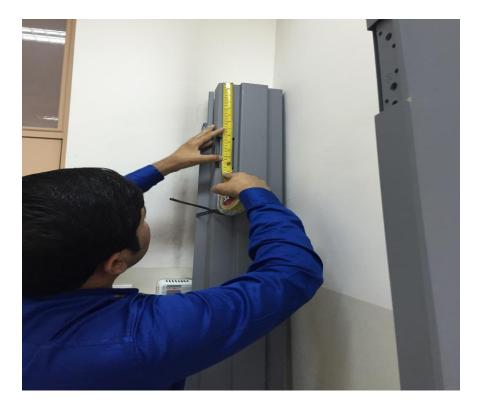
Photograph-6: Measuring hinge locations of fire door frame to confirm it meets drawing specifications.

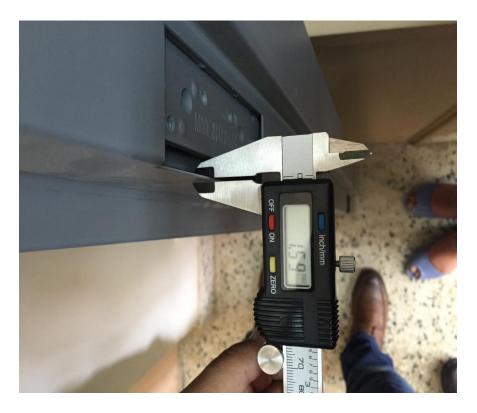
Photograph-7: Fire door Frame thickness measurement by Tt QA Engineer.

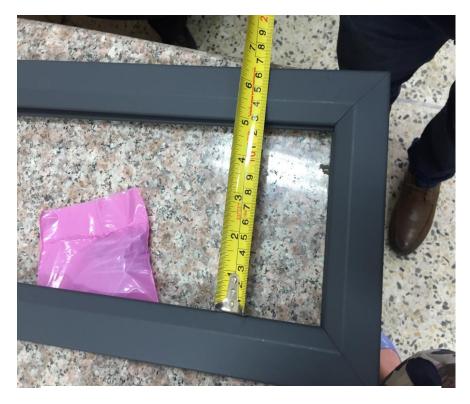
Photograph-8: Fire door Vision Lite frame width measurement by Tt QA engineer.

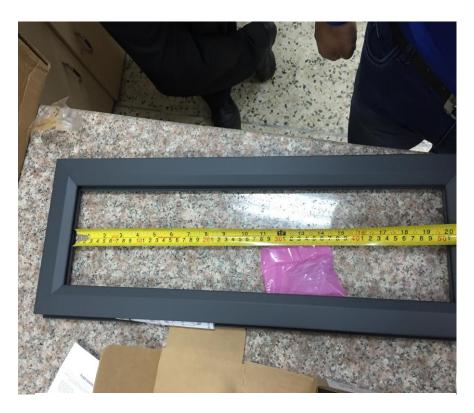
Photograph-8: Fire door Vision Lite frame height measurement by Tt QA engineer.

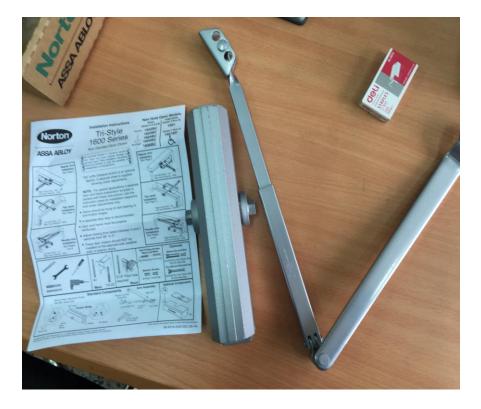
Photograph-9: Fire door closure component set showing UL Label.

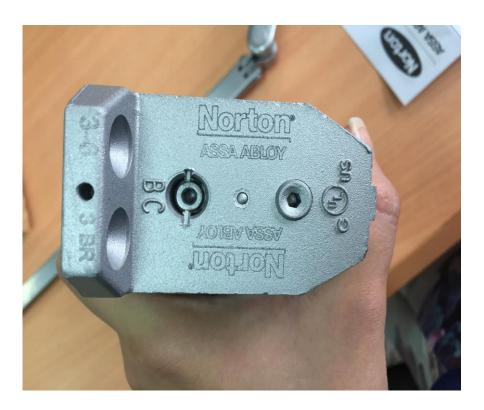
Photograph-9: UL labeled closure.

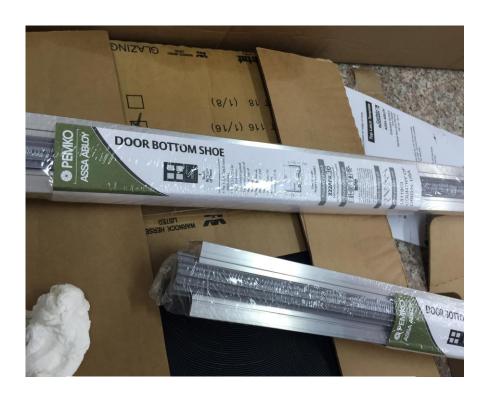
Photograph-10: Door bottom shoe and perimeter gasket.

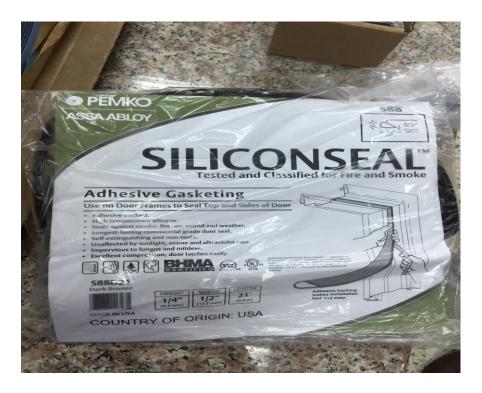
Photograph- 11: Perimeter gasket for fire doors.

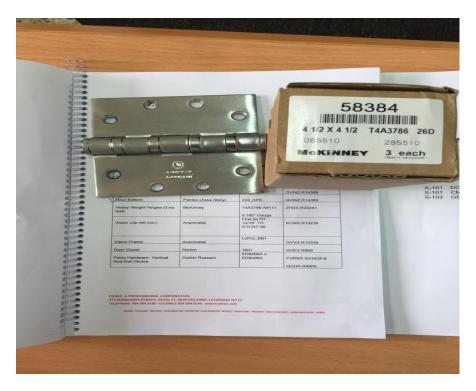
Photograph-12: Heavy weight hinges for fire door showing UL Label.

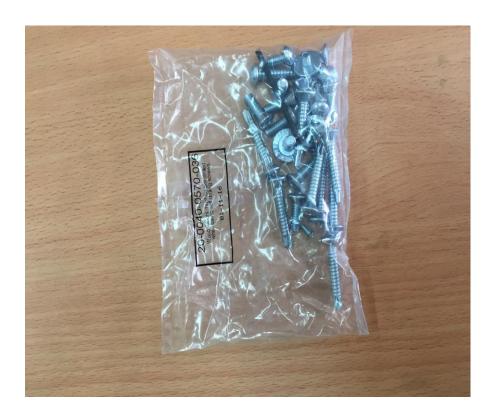
Photograph-13: Fasteners for heavy weight hinges.

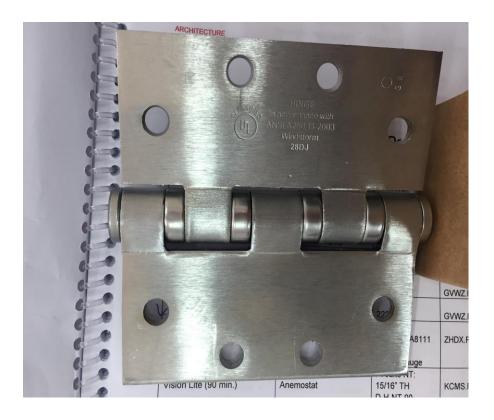
Photograph-14: Heavy Weight Hinges showing UL Standard mark.

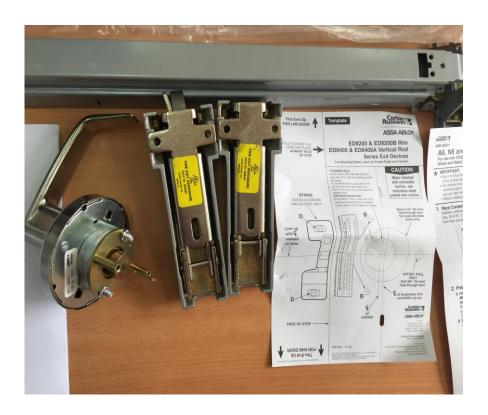
Photograph-15: Fire door handle set and panic hardware.

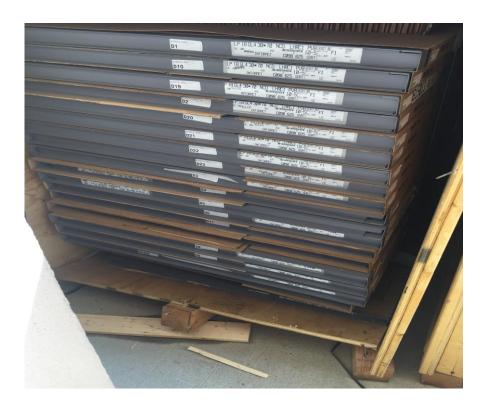
- 1. There are 24 doors bought (one as spare, saved in case of unexpected damage). They were transported to the site on May 22, 2016.
- 2. Only one sample of the door unit with the related ancillary components was unpacked for examination. The remaining stock were stored at the yard of school, covered with wooden boxes and plastic sheets.

Photograph 16: Fire doors panels stored in yard.

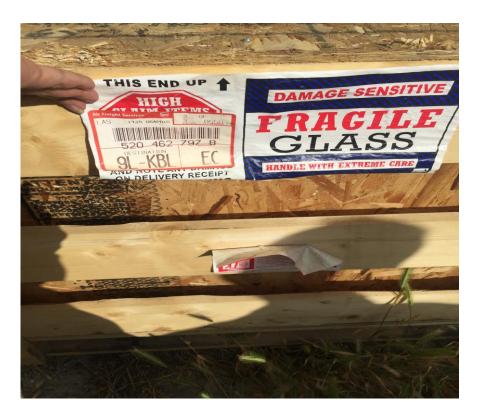
- c. Perimeter gasket
- d. Meeting stile astragal
- e. Door closures
- f. One panic hardware set- vertical rod exit device
- g. One handle set
- h. One vertical integrated door stop with sleeve in floor
- i. Heavy weight hinges (3 ea. Leaf)
- One active door astragal
- k. Vision light
- Vision Light frame
- 8. The new fire doors do not include locks/keys since it is not in their manufacturing requirement.
- 9. The new door units are designed with three required hinges per door panel (as opposed to four hinges for the existing doors). Therefore, when the new doors are installed, there will be one empty hinge location.
- 10. All door panels are going to be hung and swing in the correct directions per the drawings.
- 11. Tetra Tech engineers could not observe the Anemostat vision light/ glasses of the doors because they were packed in order to avoid breakage.

Photograph-17: Packed glass Vision Lite/Glass that was not checked because they were packed.

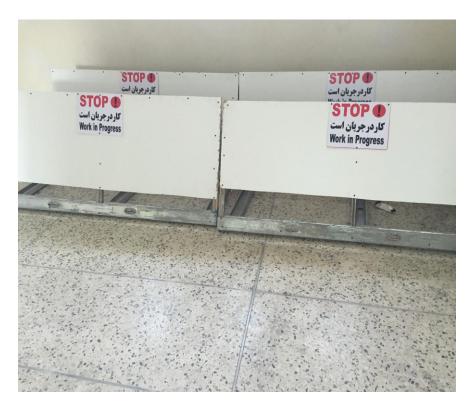
Photograph-18: Work Zone signs for student's information and safety.
